AN INVESTIGATION OF ELECTROCHEMICAL TECHNIQUES DESIGNED TO MITIGATE THE CORROSION OF STEEL IN HISTORIC REINFORCED CONCRETE STRUCTURES: FRANK LLOYD WRIGHT'S FREEMAN HOUSE, HOLLYWOOD, CA

Terry Scott Kreilick

A THESIS

2000

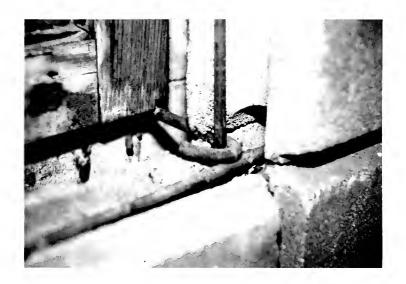
As the blocks were stacked, the two wythes were tied together with smooth steel rod looped around the reinforcing rod. The ties were not encapsulated in grout. Figures 12 and 13 show examples of the ties that connect the wythes.

Figure 12
Tie-rod connecting inner and outer wythe.
Photograph courtesy of K. Fong.

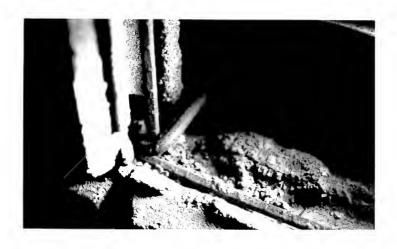
Figure 13 Tie-rod connecting inner and outer wythe.

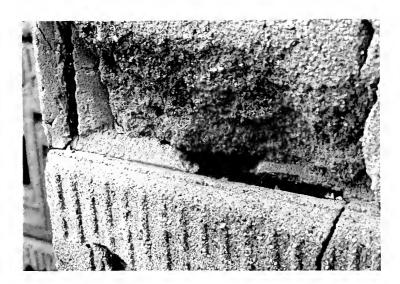
Figure 15
Detail of ring fracture of concrete block on south facade.

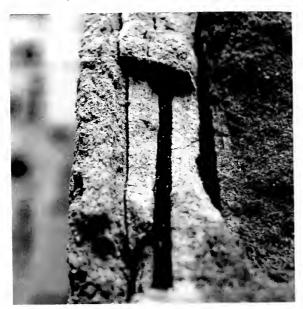
Figure 16
Detail of ring fractured corner block on the south facade.
Two vertical reinforcing rods are visible.

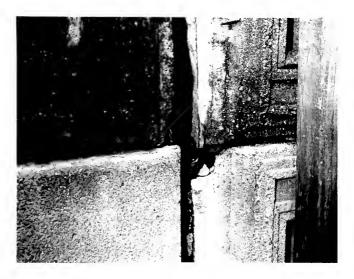
Figure 18 Detail of the intersection of four concrete blocks on the south facade.

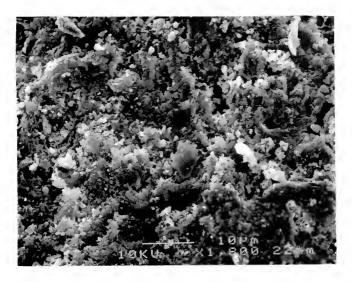
Figure 21 SEM micrograph of concrete matrix. (1,800x magnification)

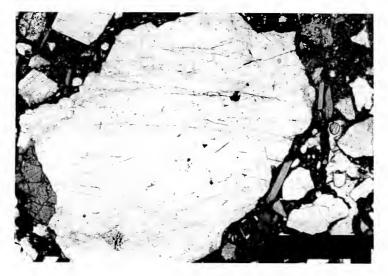
Figure 27

Optical micrograph of petrographic thin-section of Freeman House concrete. Overall view in plane-polarized light showing a large quartz crystal in the center, green amphiboles, and yellow biotite. These aggregates constitute approximately 80% of the section. The very fine matrix constitutes the remaining 20%.

(25x magnification)

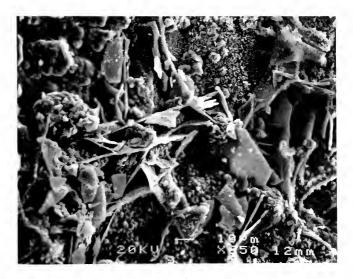
Figure 35 SEM micrograph of iron oxide on the surface of steel reinforcing rod from Freeman House. (650x magnification)
